# ECP Monitoring Report

## Water quality status and sources of pollution in the Littlestock Brook

September 2024

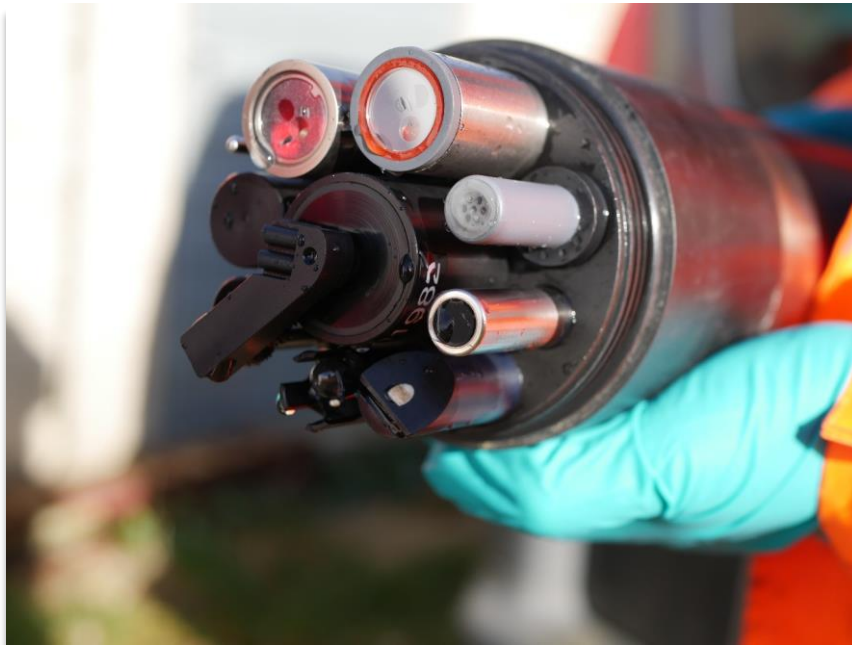
Earthwatch installed two 'Proteus Instruments' multi-parameter water quality probes in the brook during February 2022. These probes were installed ~600m upstream of the STW and ~400m downstream of the STW respectively to assess the impact of MuW STW on the brook. The probes take a reading every 15 minutes of a wide range of water quality parameters, and so to date there are over 20,000 individual readings for each of these water quality determinants. This frequency of readings helps to understand the hourly, daily and seasonal patterns of variation of the measured pollutants in great detail.

**Figure 5-1 Proteus Instruments multi-parameter probe with the protective cage removed**

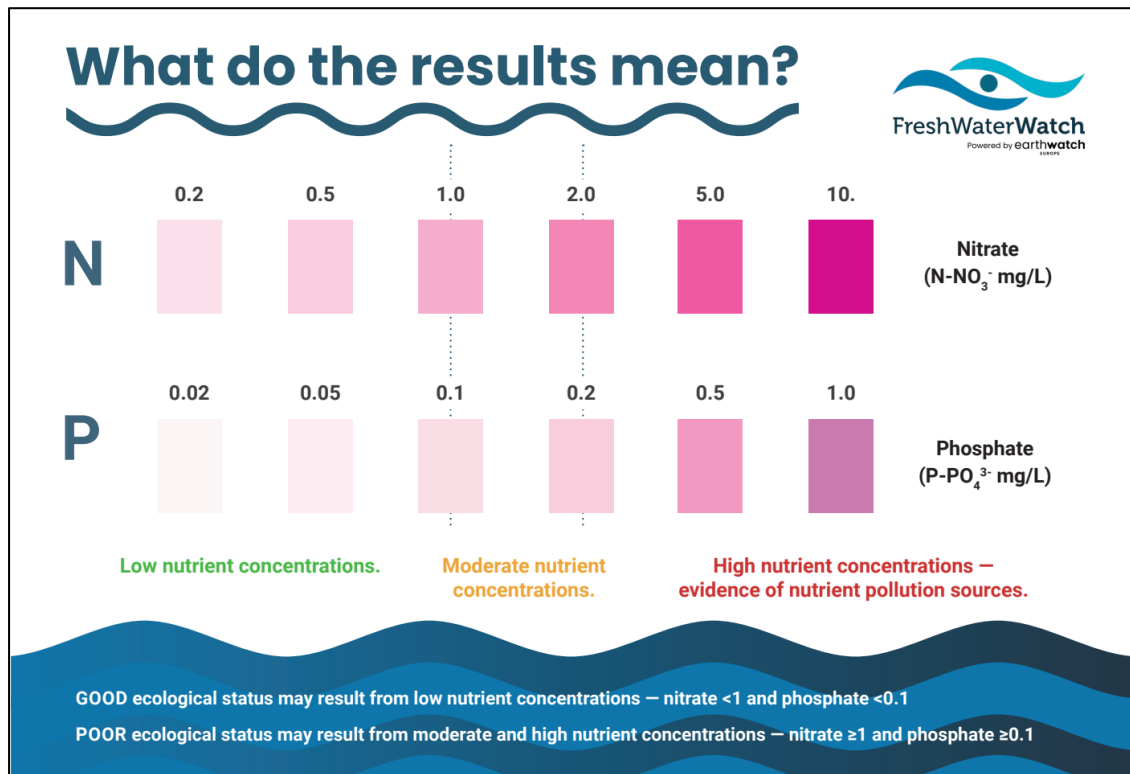
- The water quality testing includes nitrates, phosphates, and turbidity measurements and observations of algae and other indicators of river health. For the nitrate and phosphate tests, a small sample of river water is taken, and added to a pre-measured quantity of reagent in a sample tube. After 3 and 5 minutes respectively, the colour of the sample is then compared with the standard colours shown below. This gives an immediate indication of the concentrations of nitrates and phosphates present. The test results and observations are then compiled into a water quality category and hosted as a map on the Fresh Water Watch website<sup>1</sup>. Freshwater Watch sampling is typically done on a monthly basis.

Figure 5-2 Fresh Water Watch sample colour card

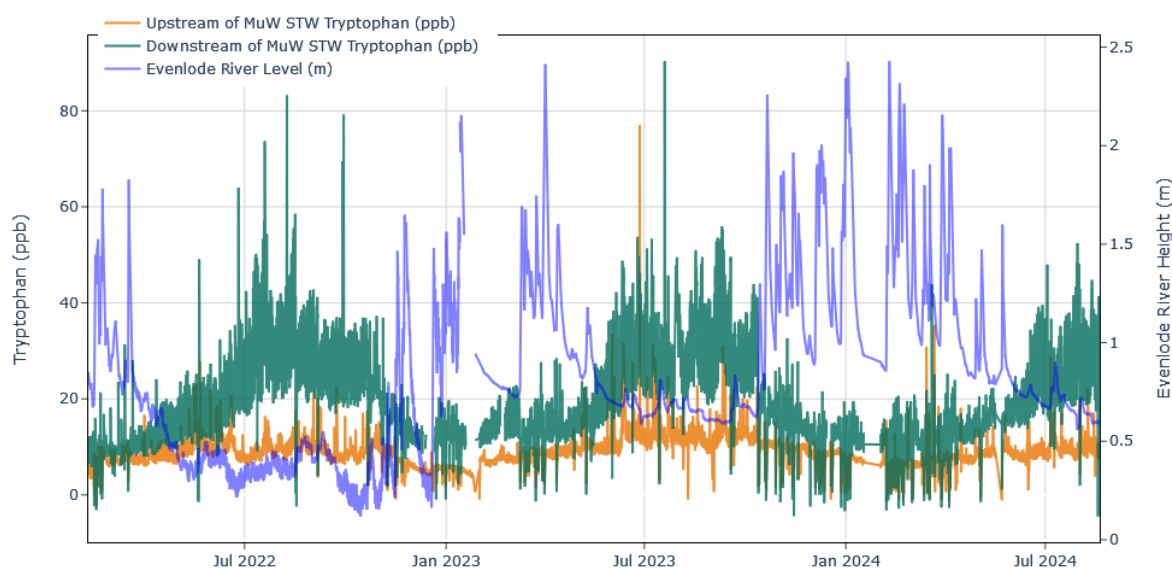
**Figure 6-1 Tryptophan concentrations.**

The first plot (Figure 6-1) covers the period since installation of the probes in February 2022 to the present day and shows much higher tryptophan levels measured by the downstream probe (green trace) compared to the upstream probe (orange trace). River levels on the Evenlode at Shipton road bridge (blue trace) are also included, as this is the nearest river level gauge available. There is a seasonal trend, where we observe higher concentrations of tryptophan in the dryer summer months when Littlestock Brook has lower flow (using the Evenlode level gauge as a surrogate). In other words, there is less water available to dilute the discharge from the STW.

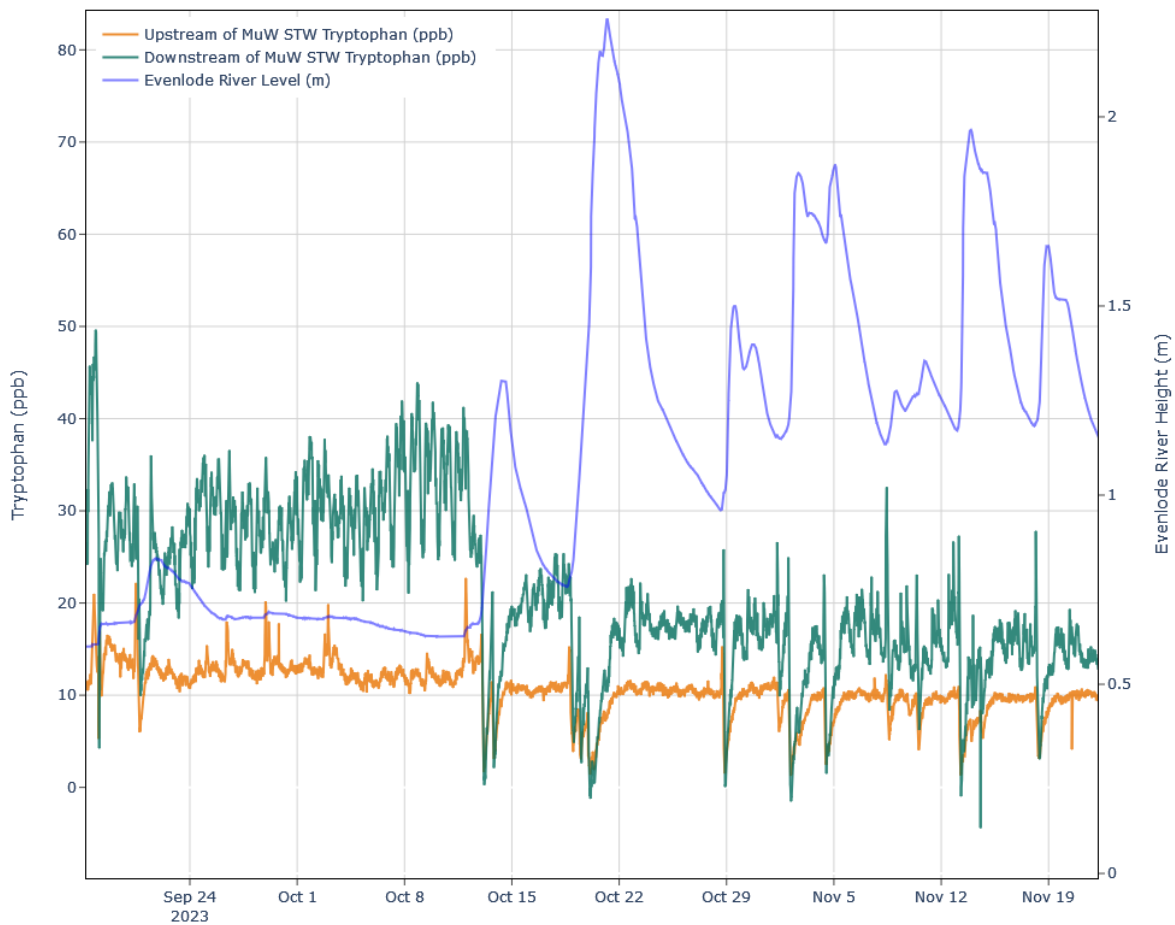
**Figure 6-2 Tryptophan concentrations**

In the second plot (Figure 6-2) we focus on September-November 2023 and show the daily rhythm of tryptophan concentration in both the upstream and downstream trace. The elevated concentrations downstream caused by the discharge from the STW are also evident. Although the observed effect is the variation in tryptophan ‘concentration’, it closely follows the flow of the discharge from the STW (see Figure 6-3). This suggests that the brook is saturated and there is insufficient dilution in the brook to absorb the volume and concentration of effluent discharged by the STW. This effect is particularly obvious (up until ~10<sup>th</sup> Oct), before the rain starts and increases the flow and dilution available in the brook.

This phenomenon is especially obvious during end of summer ‘low-flow’ conditions. A change occurs on ~10<sup>th</sup> October, when tryptophan concentrations suddenly fell at the same time that water level (blue trace) suddenly rose following rainfall. Because upstream and downstream concentrations both fell, we can deduce that this is *not* because the STW outflow suddenly decreased, but instead because the flow in the Littlestock Brook **increased** due to rainfall, diluting the constant outflow of sewage from the STW.

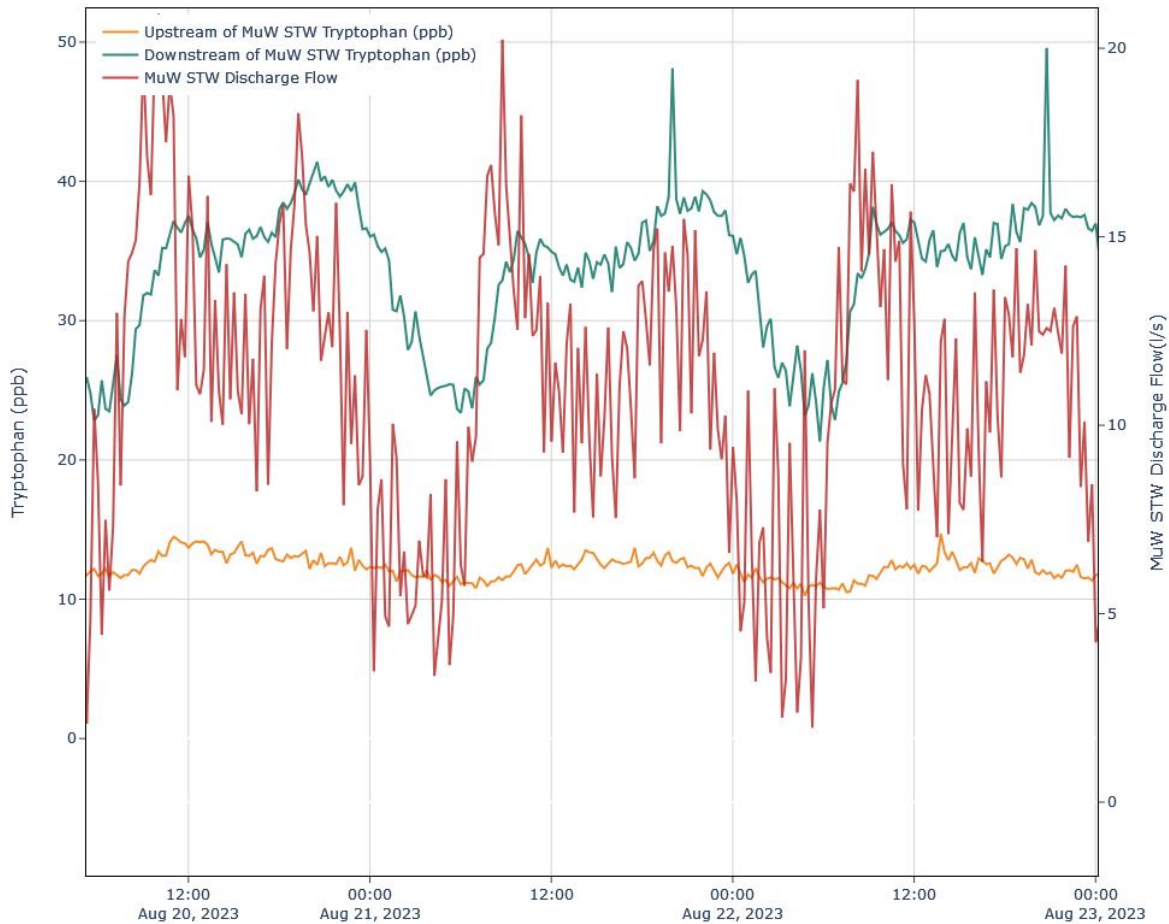
**Figure 6-3 Tryptophan concentrations.** As we focus in further to a period of less than a week (Figure 6-3) and add the trace for discharge flow from MuW STW (red), you can see the close correlation between STW flow and the downstream Tryptophan trace (green) illustrating the link between the STW discharge and water quality in the brook. The STW discharge flow and the downstream tryptophan concentrations show the expected domestic sewage flow pattern from the daily cycle of toilet flushing/ showering/ clothes washing/ dishwashing, reflecting the activities of the residents of Shipton/ Milton/ Ascott and surrounding villages as their waste passes through MuW STW, is discharged to Littlestock Brook and impacts the water course downstream.

The concentration of tryptophan / MuW STW discharge flow drop overnight as people go to bed in the evening; there are a couple of sharp upticks in the early hours, which we believe are increased flow through the STW as various pumping stations in the network reach a level to turn the pumps on, sharply increasing the flow to the works. Then at 7am~8am as people wake up and start flushing, showering and washing, the flow starts to increase to a peak at around 11am, before a plateau/dip in the early afternoon. There is another uptick at around 5pm as people come home from work/school, rising until late evening, when it starts to drop again as people go to bed and the cycle repeats.

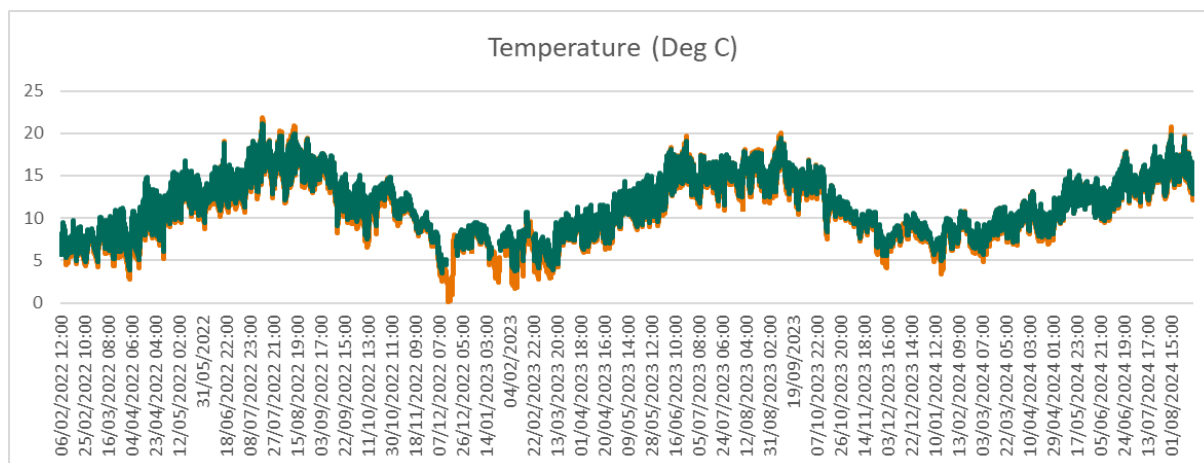
The chart below shows the results from upstream of the STW in orange and the downstream readings in green for the whole study period. There is a very obvious seasonal trend between summer and winter, but only a very marginal increase in the downstream temperature. These data show good agreement with the EA samples that are taken approximately 10m from the downstream sonde at Meadow Lane bridge.

**Figure 6-4 Temperature readings from the sondes.**

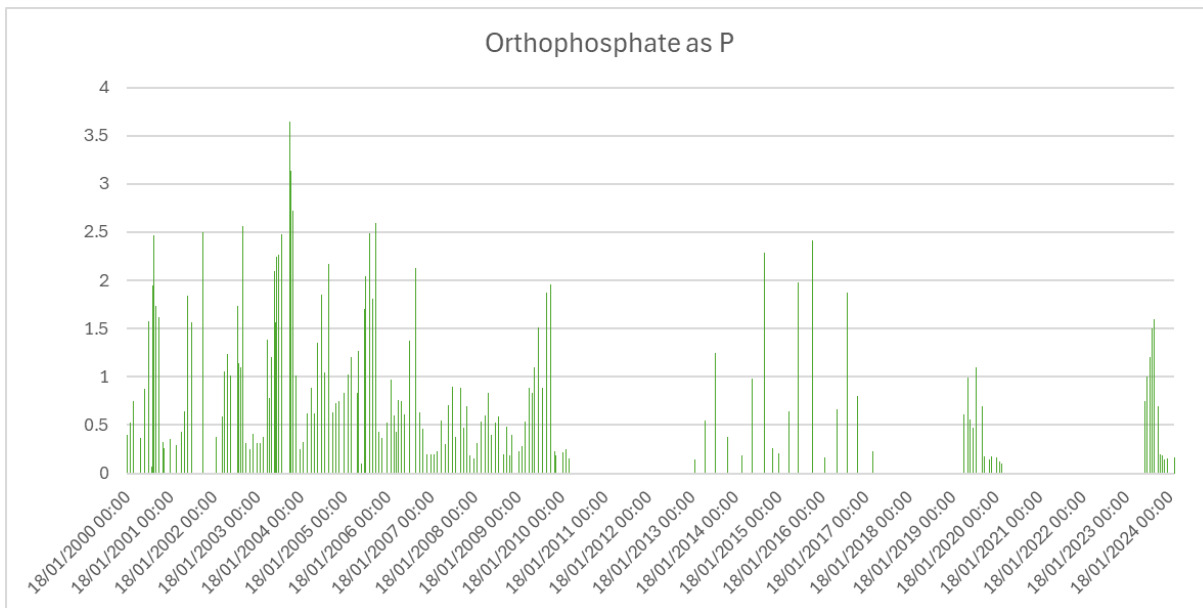
**Figure 6-5 Phosphates (in the form of Orthophosphate as P) as measured by the EA at Meadow Lane bridge.**

Over the period 2023/2024 the EA have taken 14 samples. The average of these 14 samples is 0.64 mg/l (moderate), but what these results do not show is the seasonal trend that we can see from the sonde (see the chart below). If the 14 EA samples are split summer/winter, then the averages become 1.05mg/l (poor) in summer and 0.23mg/l (moderate) in winter when additional dilution is available.

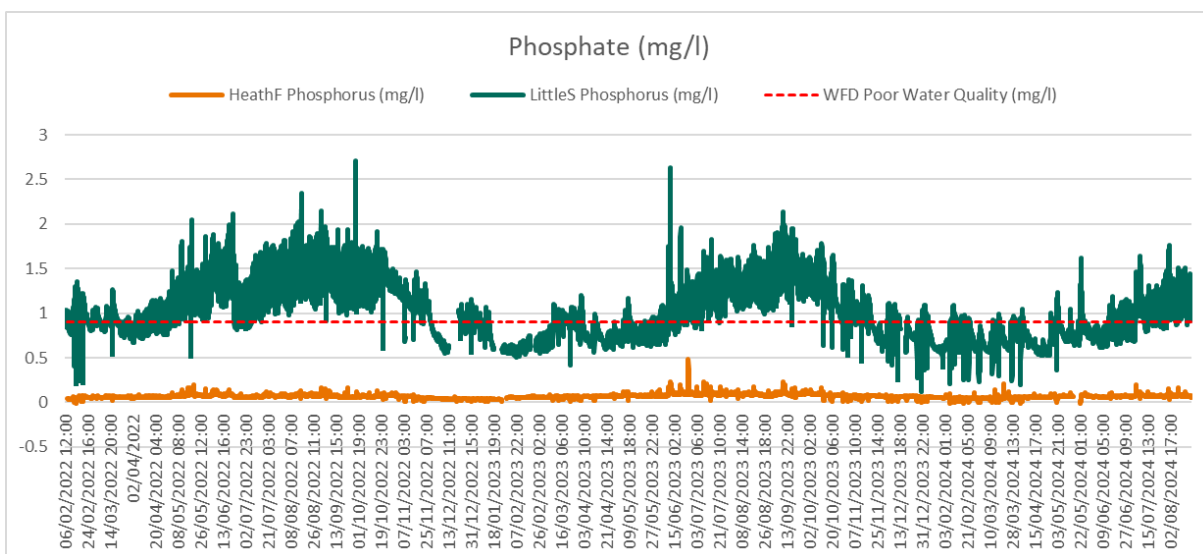
**Figure 6-6 Phosphate readings from the sondes** Although the sonde measures phosphates by a different methodology to the EA, there is reasonable correlation between the sonde readings for phosphate and the EA sample results. ( $R^2$  value of 0.58 although, this comparison is only possible for a limited number of samples (14 EA samples taken in 2023/2024).

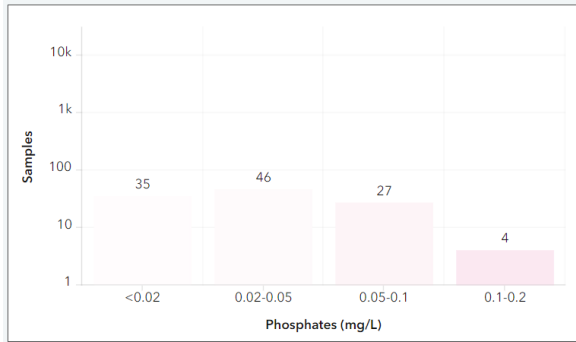
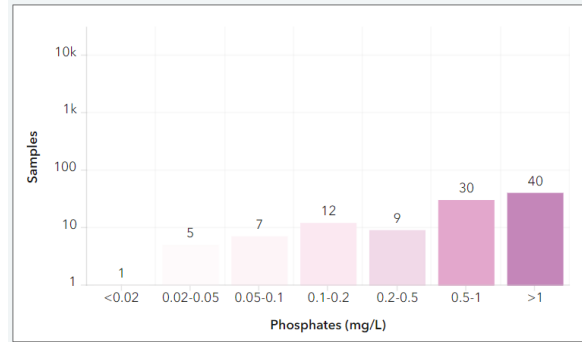
**Table 2 Citizen scientist phosphate samples taken upstream and downstream of MuW STW**

Both data sets (EA and sonde) are also in the same range as reported by CS at Meadow Lane bridge (though most of these sample are above the range that the CS test kits can measure (>1mg/l)). Out of the 103 samples taken by CS at Meadow Lane, below MuW STW, 70 showed high levels of phosphates (30 (0.5-1 mg/l) + 40 (>1 mg/l)).

Citizen scientist FWW samples taken upstream of MuW STW

Citizen scientist FWW samples taken at Meadow Lane bridge downstream of MuW STW

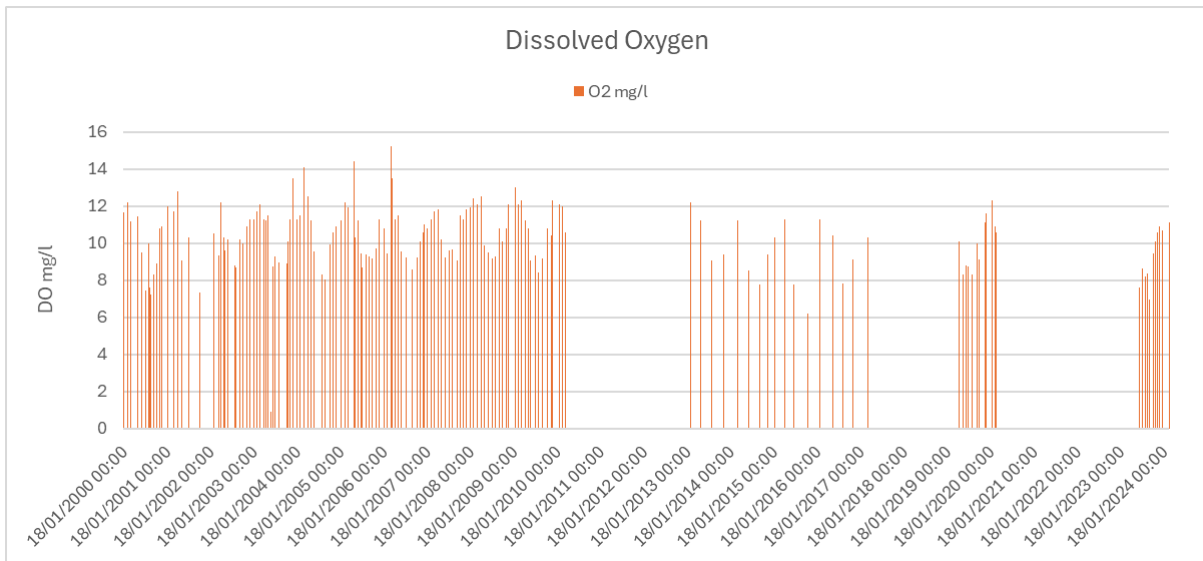
Comparing these limits with the results reported by the EA from Meadow Lane bridge, we see that they record levels between 7mg/l and 11mg/l in their results. The sonde results presented in Figure 6-8 show that the intermittent sampling carried out by the EA fails to illustrate the full

picture. The EA take samples during office hours and miss critical peaks during the day shown by the sonde. The impact of seasonal differences is also difficult to spot when taking monthly samples, for example, there are only a few samples during the summer when dilutions in the brook are low.

**Figure 6-7 Spot samples of O<sub>2</sub> (mg/l) as measured by the EA at Meadow Lane bridge.**

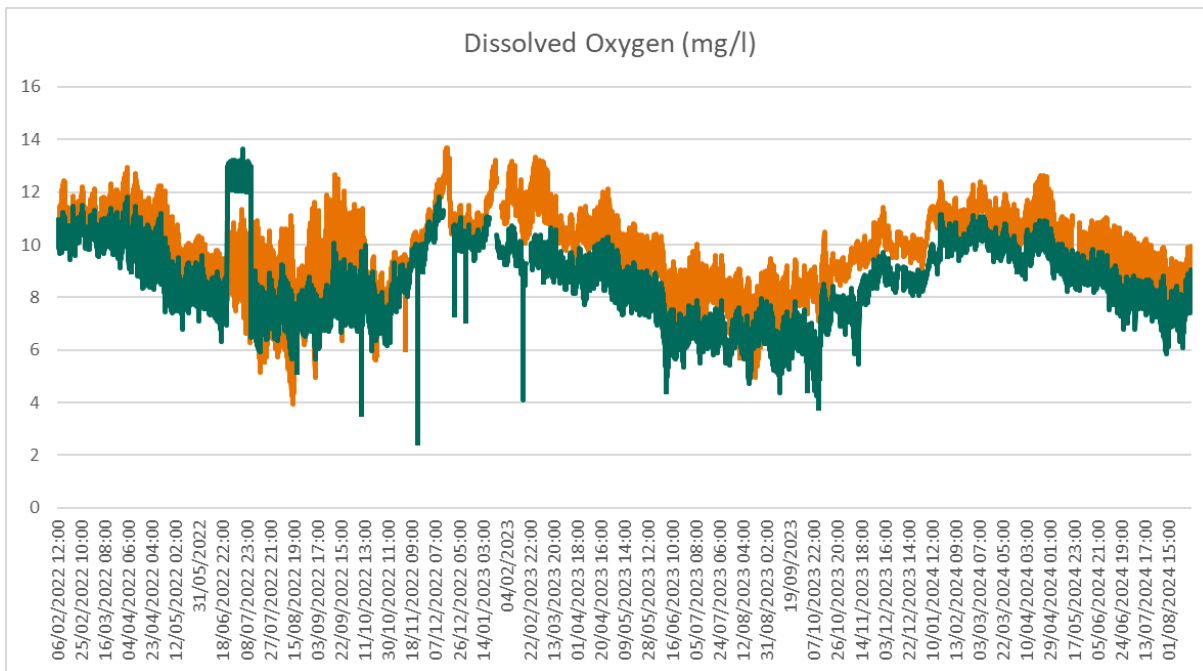
We see from the sonde results that dissolved oxygen levels are lower downstream of MuW STW discharge than they are upstream (Figure 7-8). A daily fluctuation is seen as plants and algae produce O<sub>2</sub> during the day when they photosynthesise, and use up O<sub>2</sub> during the night as they respire. Bacteria also use up O<sub>2</sub> as they respire. There is also a distinct seasonal trend. (A fault with the downstream sonde can be observed in July 2022 in the downstream DO (mg/l) trace and these data are omitted from the assessment.)

**Figure 6-8 O<sub>2</sub> (mg/l) readings from the sondes.**

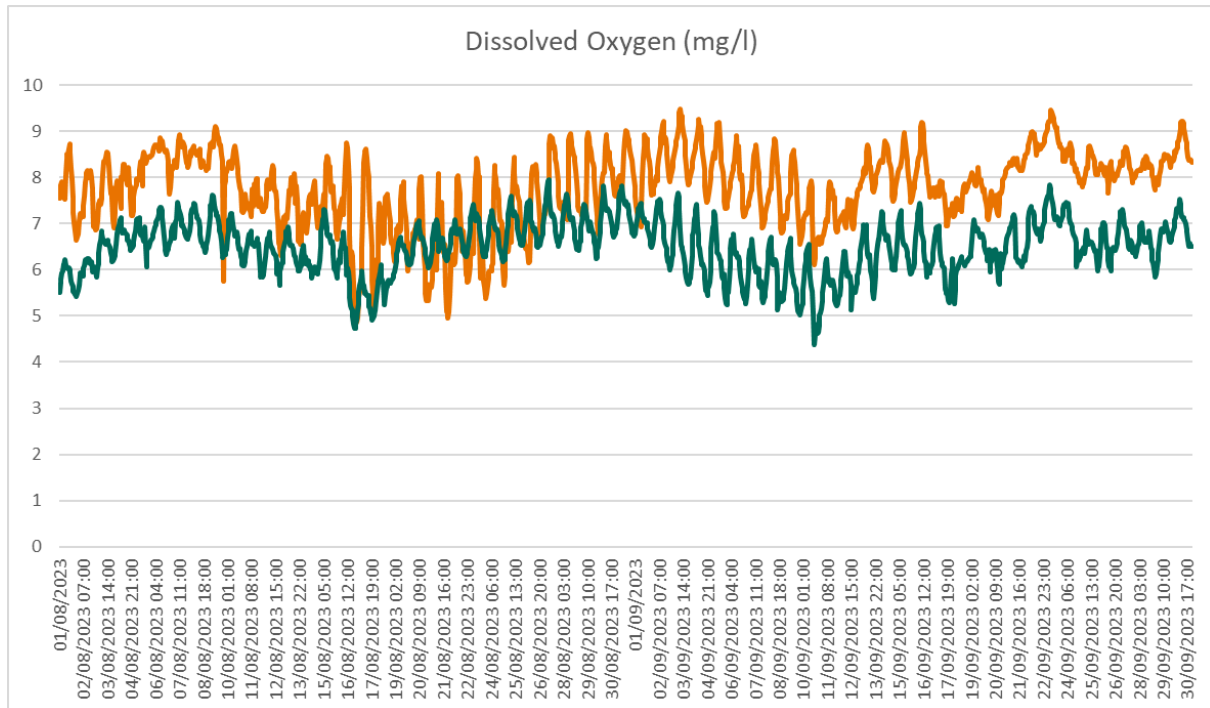
We can see from the trace for July to September 2023 (Figure 7-9), that in the warmer temperatures of the summer months, DO levels do dip below this 5mg/l threshold, especially at periods during the daily cycles and are likely to stress species that would survive in a healthy stream.

**Figure 6-9 O<sub>2</sub> (mg/l) readings from the sondes Aug/Sep 2023.** This analysis shows that there are periods when oxygen levels in the Littlestock Brook downstream of the STW fall to levels that would stress some of the species that should live there. These periods are missed by the periodic sampling carried out by the EA.

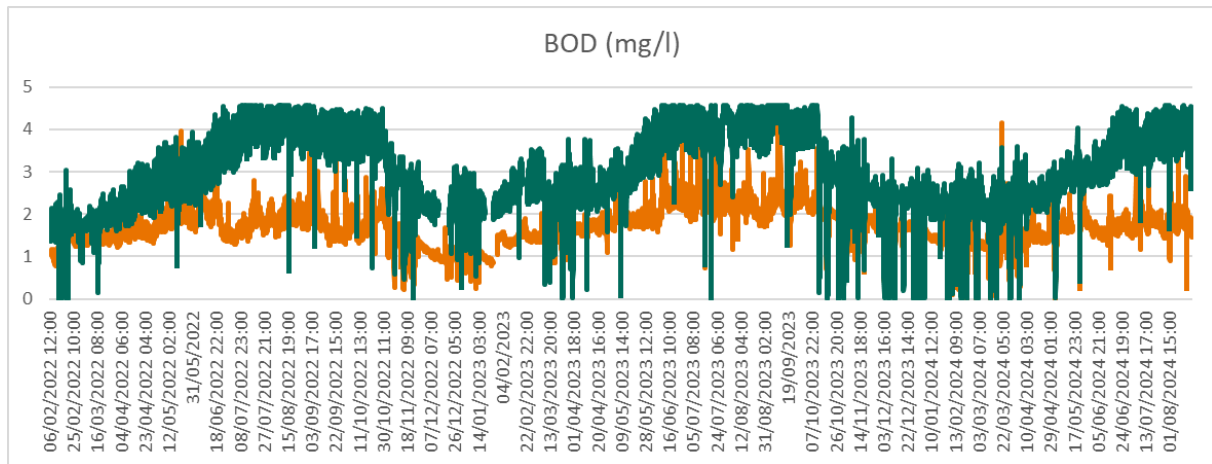
**Figure 6-10 BOD readings from the sondes.**

The downstream sonde consistently reads higher than the upstream probe illustrating the influence of MuW STW discharge (Figure 7-10). There is also an obvious seasonal trend both upstream and downstream. The more exaggerated downstream trend reflects the impact of the discharge from MuW STW and the lower dilutions available in the brook during the summer when river flows are low. The picture is incomplete due to the sonde failing to read above ~4.5 mg/l. The reasons for this are being investigated.

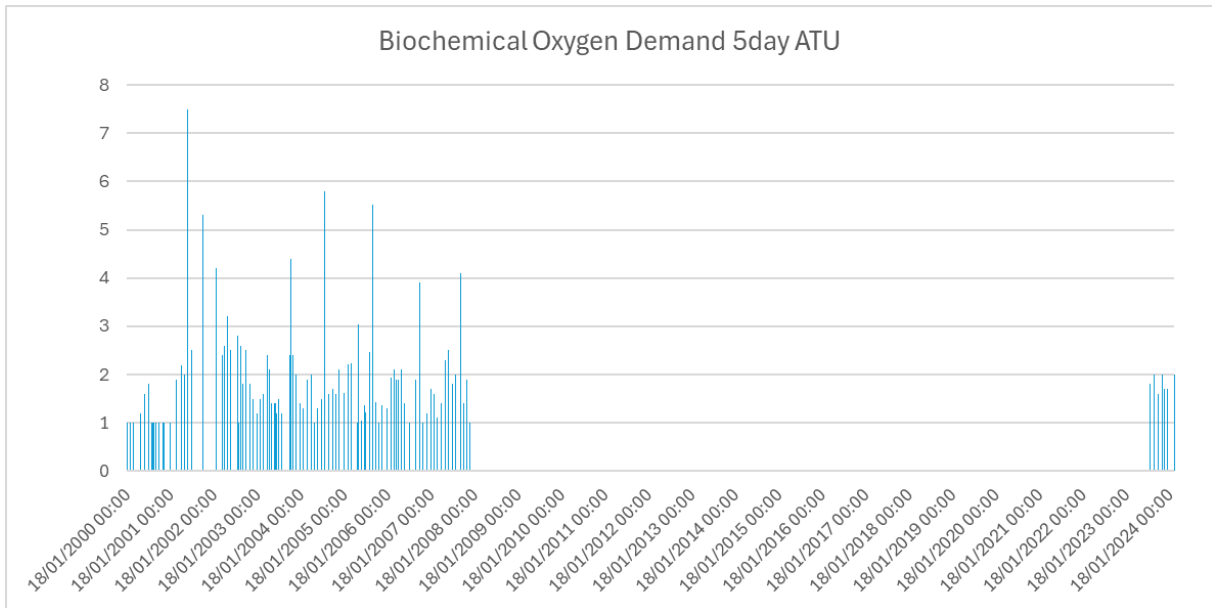
**Figure 6-11 BOD Measurements recorded by the EA at Meadow Lane Bridge.**

Unfortunately, there is a gap in the EA samples between 2008 and 2023, so there is only a limited dataset with which to compare (Figure 7-11). The sonde BOD readings are roughly double those measured by the EA. BOD is a calculated determinant in the sonde rather than measured directly, so it is difficult to have confidence in these absolute numbers reported, though the trend daily and annual trends are obvious. Unfortunately, we have not been able to establish a good correlation between the sonde and the EA samples, due to the small number of coincident samples.

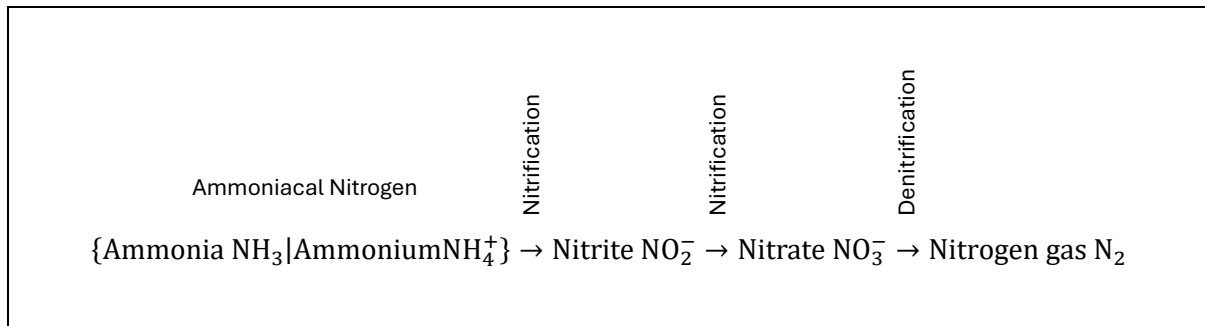
ones by the time they are released to the environment. A brief overview of the mechanisms involved in the nitrogen cycle is shown below.

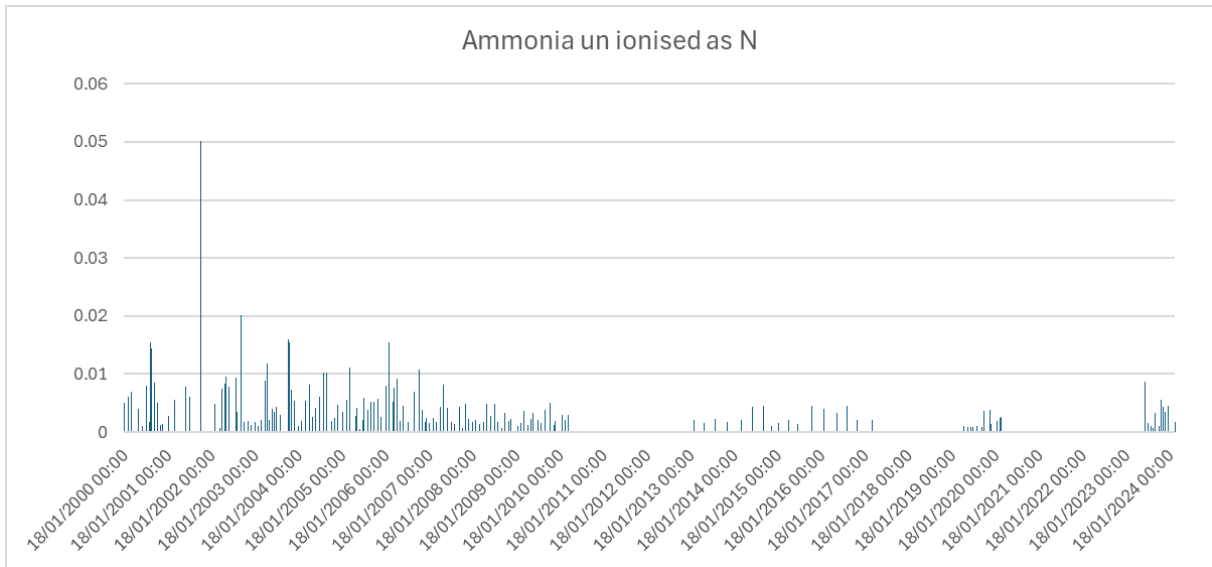
**Figure 6-12 Ammonia Measurements recorded by the EA at Meadow Lane Bridge.**

The samples taken by the EA are well below the level set by the WFD.

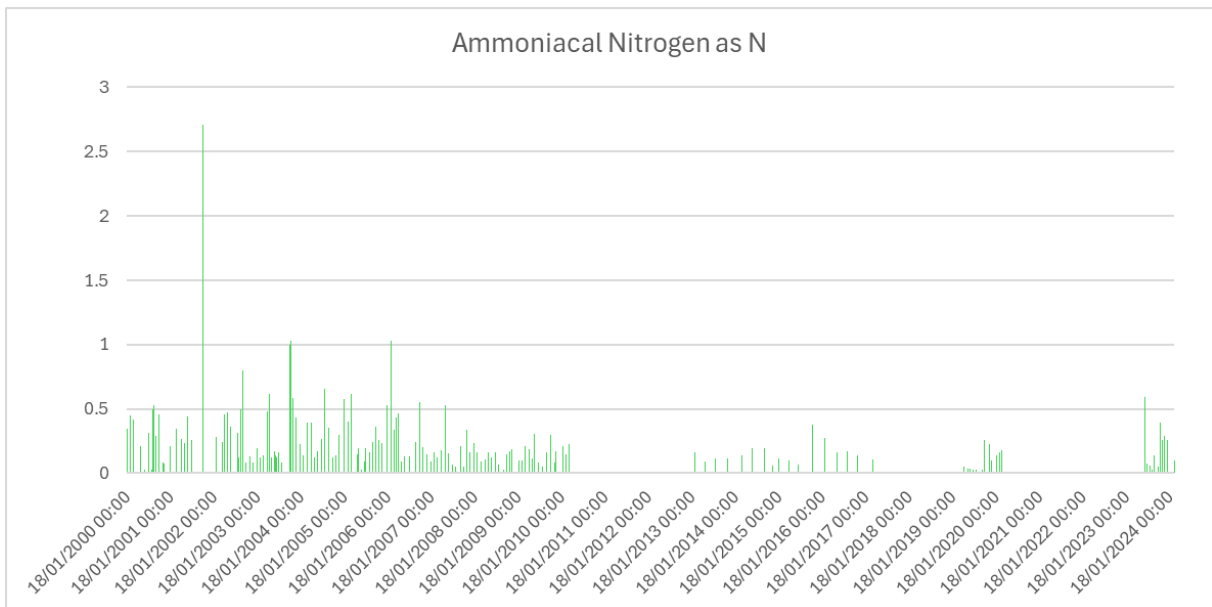
**Figure 6-13 Ammonia measurements recorded by the EA at Meadow Lane Bridge.**

The sample results show slightly elevated levels of ammoniacal nitrogen as N in Littlestock Brook, especially in historical samples. More recently the samples have typically been below 0.5mg/l. In 2023/2024 these samples have averaged 0.21mg/l, i.e., approximately 1/3 of the level measured in the discharge from MuW STW (0.61mg/l).

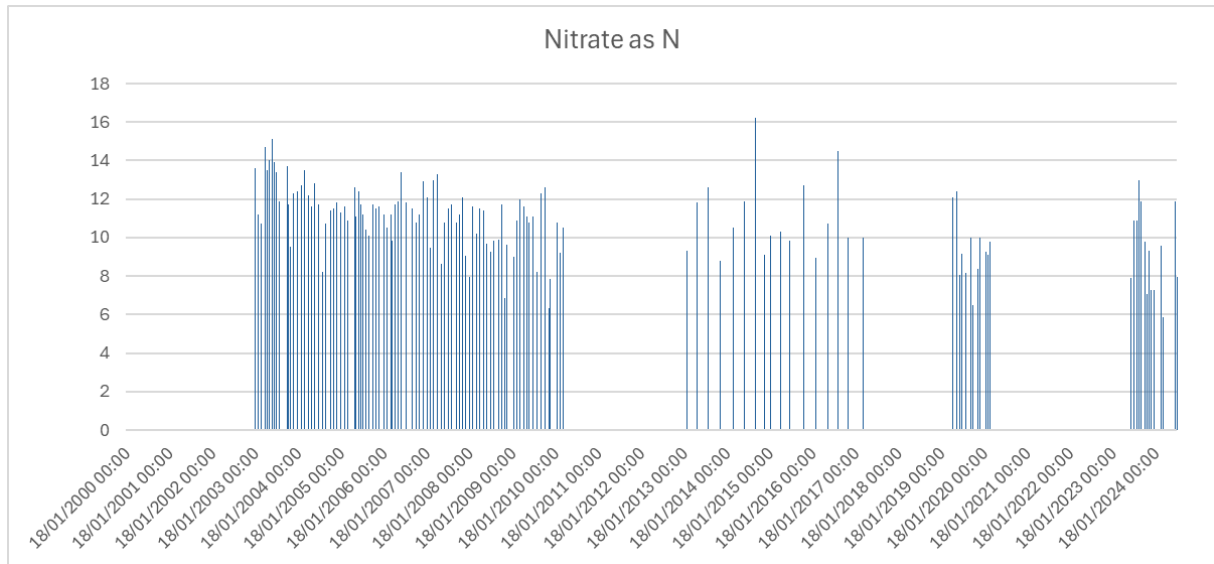
Both the EA and citizen scientists measure nitrate at Meadow Lane Bridge. The EA samples typically show nitrate concentrations of ~6 – 12mg/l.

**Figure 6-14 Nitrate Measurements recorded by the EA at Meadow Lane Bridge.**

Comparing the EA’s nitrate data (Figure 6-14) with the citizen scientists’ nitrate data (Figure 7-15, right hand chart), we see that the two sets of results are consistent, and that the majority of the results downstream of the STW are in the more polluted range (‘5-10mg/l’ and ‘>10mg/l’).

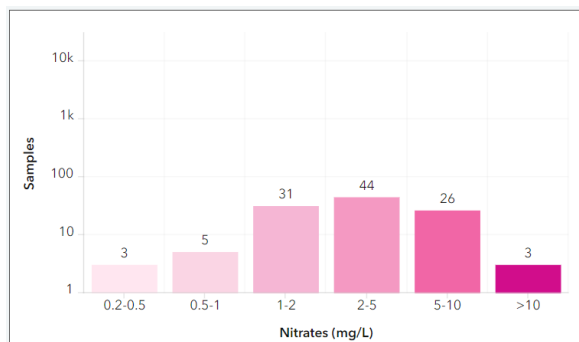
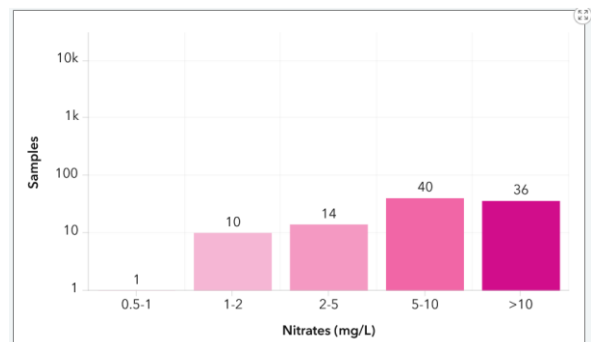
The benefit of the citizen scientist FWW samples is the ability to compare upstream and downstream concentrations. Although there are some high results upstream, there is a marked increase in the frequency of high results that were recorded downstream of MuW STW. Of the 104 samples taken by citizen scientists below MuW STW, 76 showed high levels of nitrates (40+36).

citizen scientist FWW samples taken upstream of MuW STW

Citizen scientist FWW samples taken at Meadow Lane bridge downstream of MuW STW

**Figure 6-15 Citizen scientist samples taken upstream and downstream of MuW STW**

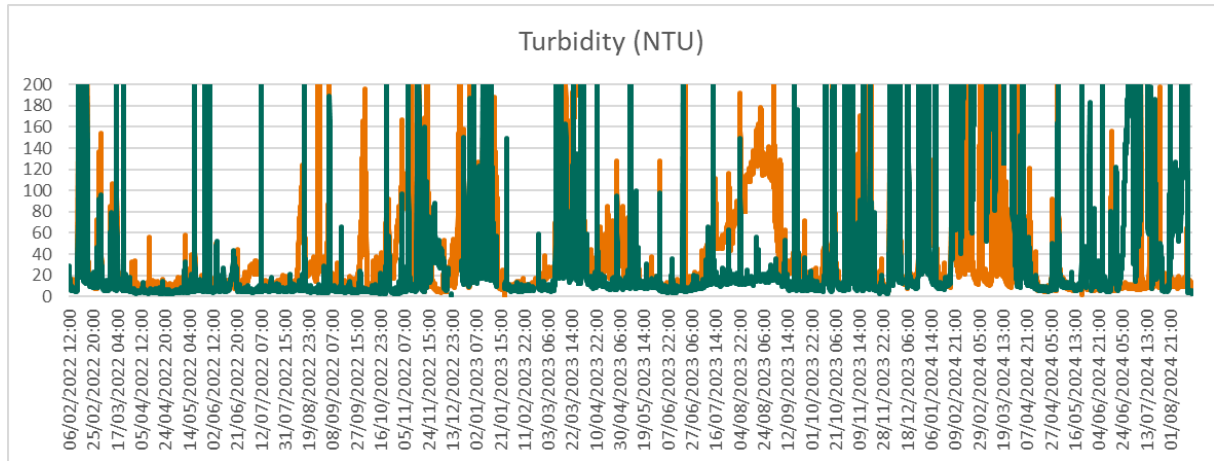
**Figure 6-16 Turbidity readings from the sondes**

Turbidity is a measure of the “murkiness” or muddiness of the water and is measured by how much light is absorbed by particulate matter as it passes through the water. This could include for example algae, or silt from soil runoff in the catchment. Whilst rivers require some sediment for healthy functioning, excess fine sediment can settle on the river bed, reducing available habitat and smothering the species living there. Unfortunately, during storm events, the levels of sediment suspended in the watercourse can quickly overwhelm the turbidity sensor in the probe.

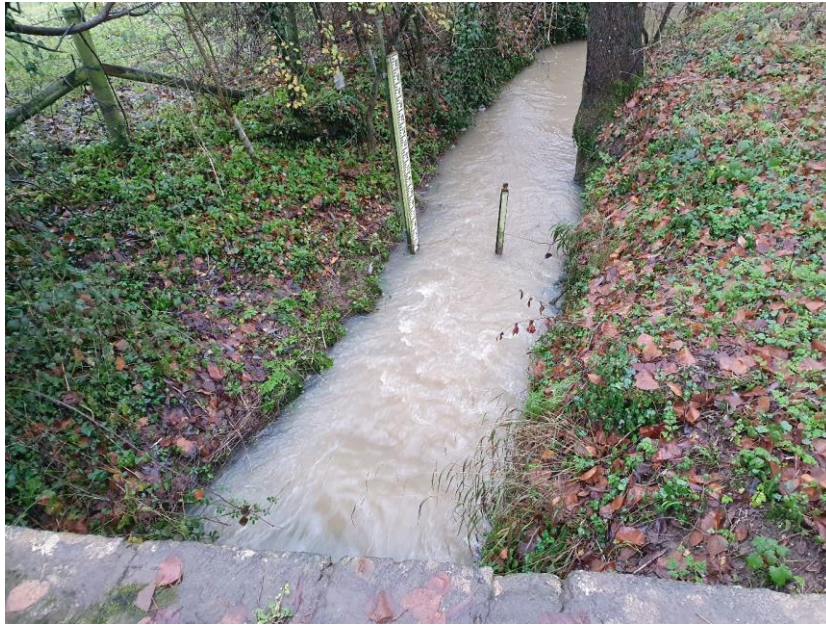
Turbidity is heavily influenced by rainfall and run-off from farmland upstream. Although significant work has already been done by farms in the area to capture this surface water run-off, these results show that further work is required to trap run-off and allow sediment to be deposited before discharge to the stream. Figure 7-17 illustrates the effects of sediment on the Littlestock Brook during a rainfall event.

**Figure 6-17 Discolouration of the Littlestock Brook upstream of MuW STW during rainfall**

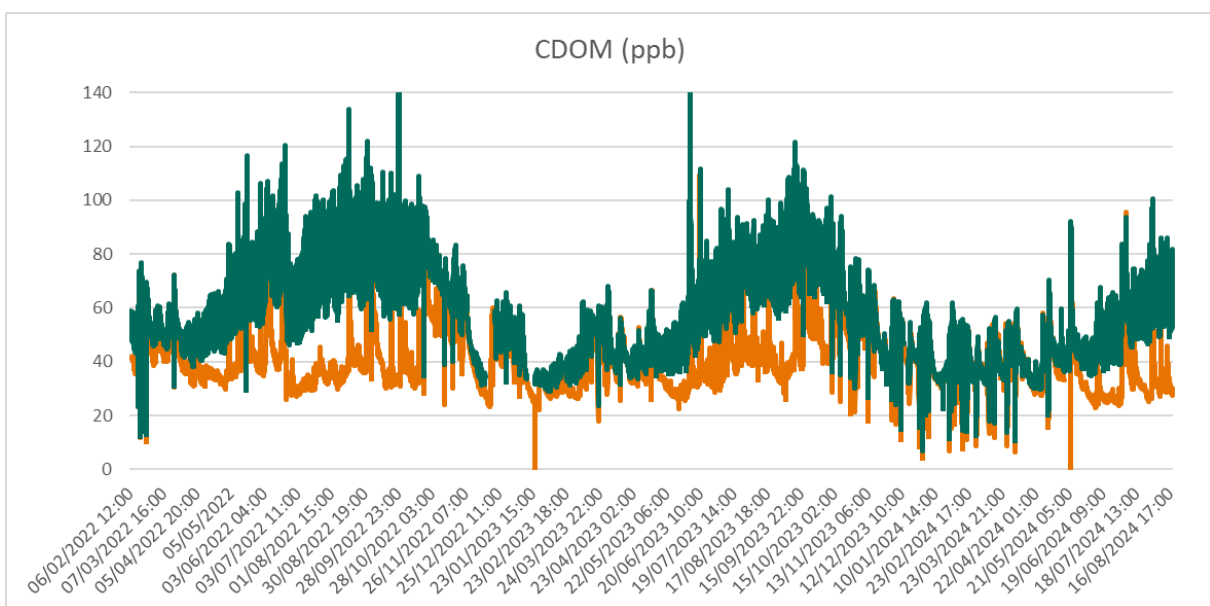
CDOM is also a proxy of organic matter, similar to tryptophan. However, it relates more to fulvic-like/carbon components of the total organic matter load in the water. The sonde directly measures this component by optical means, with straightforward and well understood technology providing data at a high confidence level. There are no environmental quality standards for CDOM, but the trace shows the familiar seasonal and daily pattern discussed earlier (Figure 7-18), with the downstream trace (green) showing elevated levels of CDOM compared to upstream (orange trace). It confirms that MuW STW is a significant source of organic matter in the Littlestock Brook, and therefore the most significant contributor to the poor water quality.

**Figure 6-18 CDOM readings from the sondes.**

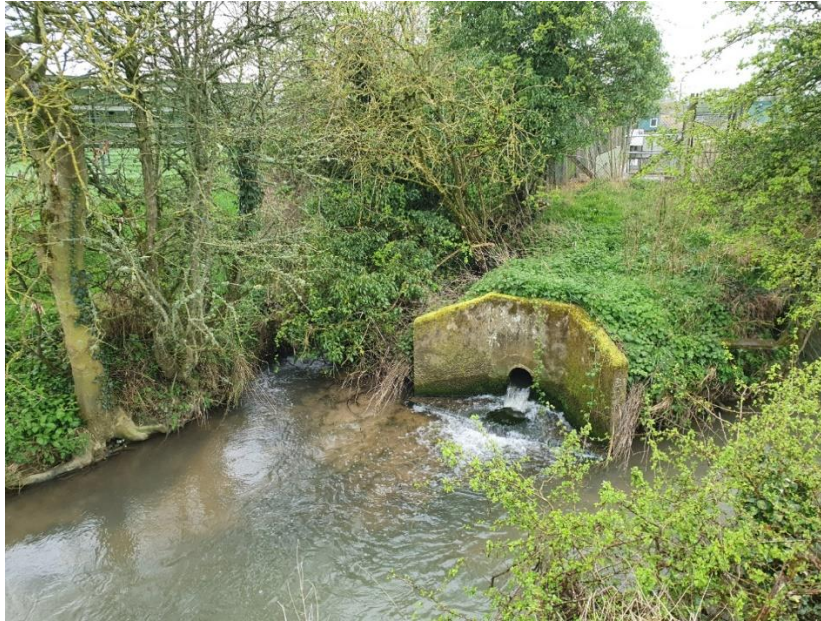
**Figure 7-1 The discharge point from MuW STW into Littlestock Brook**

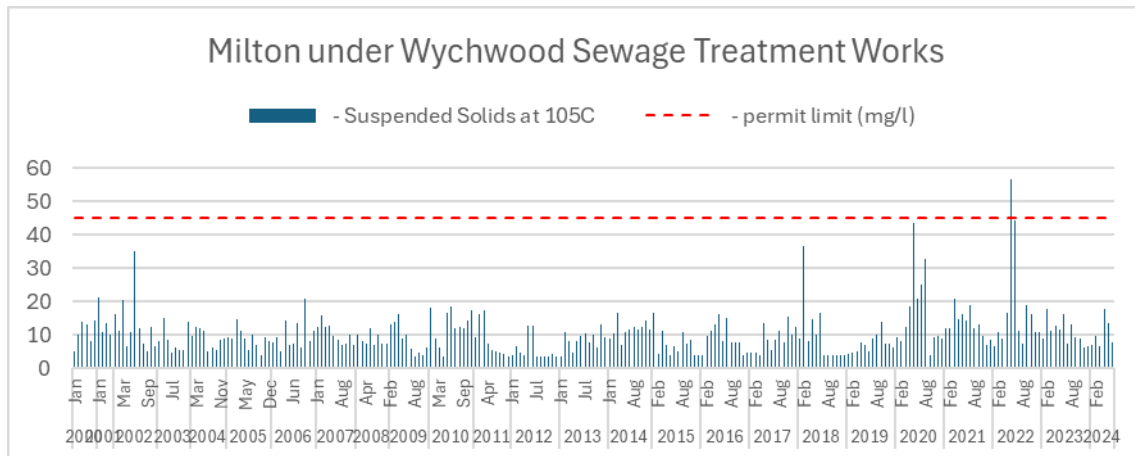
**Figure 7-2 Final effluent suspended solids (limit 45mg/l).**

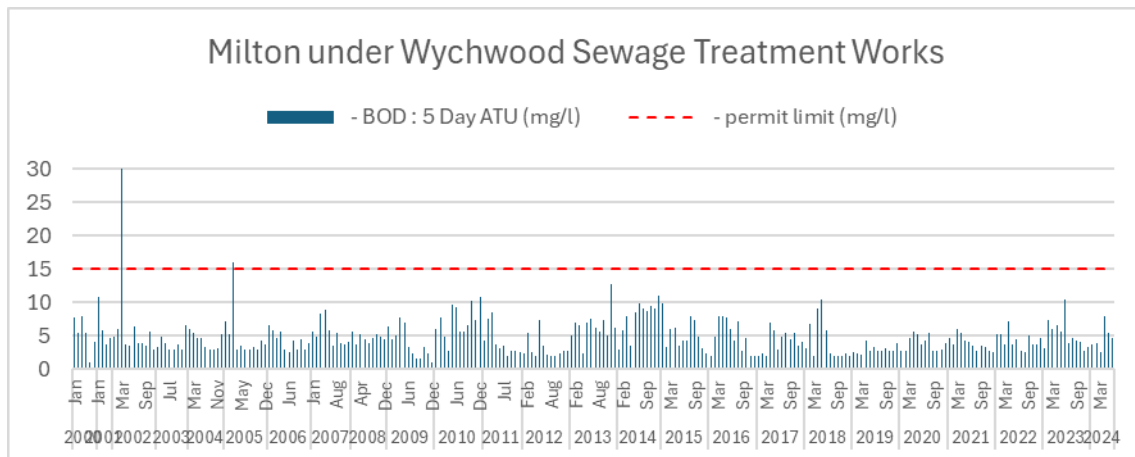
**Figure 7-3 Final effluent BOD (limit 15mg/l).**

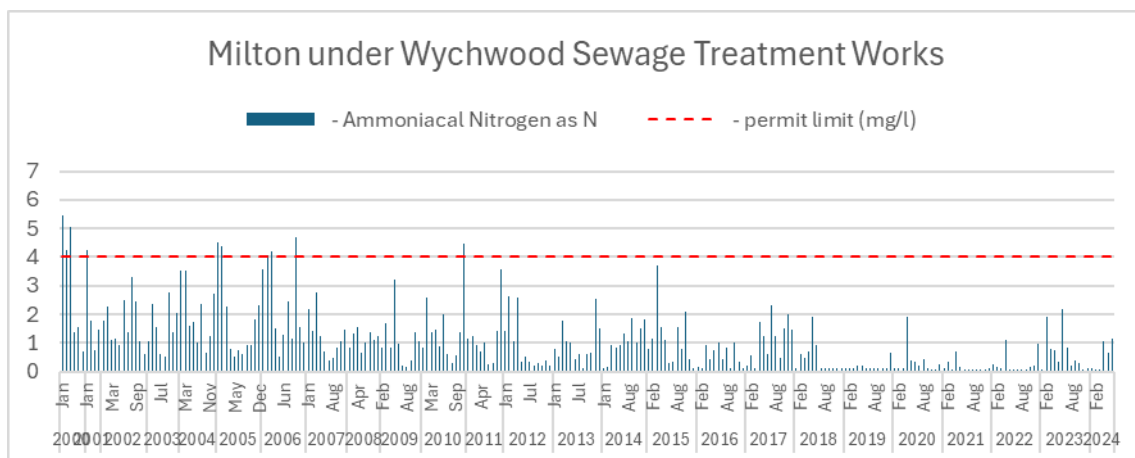
**Figure 7-4 Final effluent Ammoniacal Nitrogen as N (limit 4mg/l).**

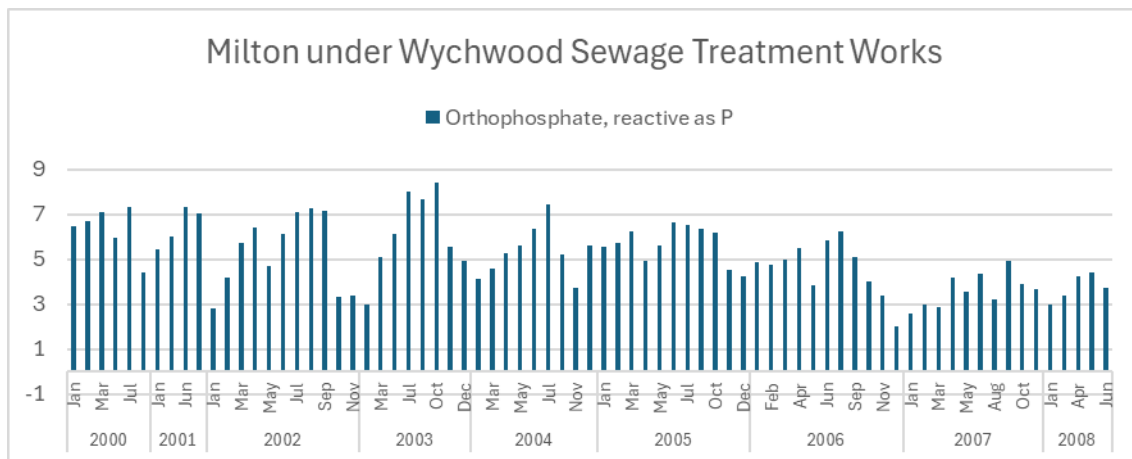
There are sample results recorded from the discharge for orthophosphate as phosphate(P). Orthophosphate is sometimes referred to simply as “phosphate” or “reactive phosphorus”. In this instance (Figure 8-5), as it is reported as P, we can use that as a direct indication of the phosphate levels discharged to the Littlestock Brook.

**Figure 7-5 Final effluent Orthophosphate, reactive as P (no limit set).**

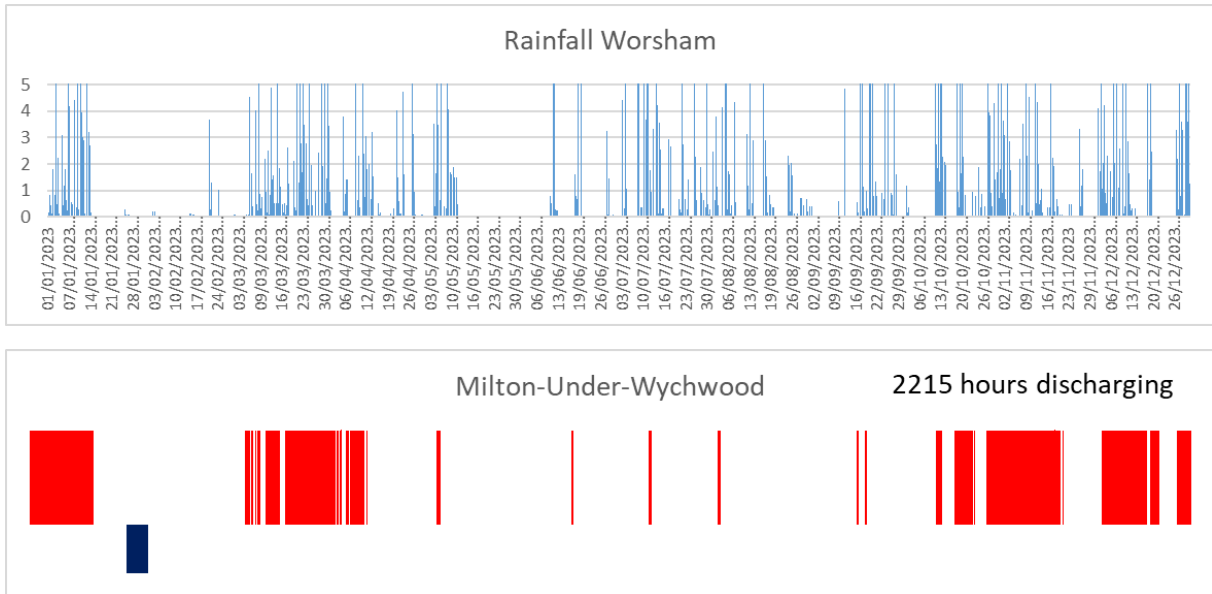
From Figures 9-1 and 9-2 it is obvious that this storm sewage overflow operates far more frequently than would be expected. The overflow operated for over 2,200 hours in 2023 and over 2,000 hours between January and October 2024. The MUW storm sewage overflow has the highest number of discharge hours in the Evenlode catchment. The Storm Overflow discharges untreated sewage far more frequently than could be explained by 'storm sewage effluent resulting from rainfall or snowmelt'.

**Figure 8-1 Storm Overflow operation during 2023.**

Dates are aligned vertically between Rainfall at Worsham mill and MuW STW Storm Overflow discharge operation (Red bars indicated untreated sewage being discharged, blue bars indicate that the 'Event Duration Monitor' was offline).
