# ECP Monitoring Report

## Water quality status and sources of pollution in the Littlestock Brook

September 2024

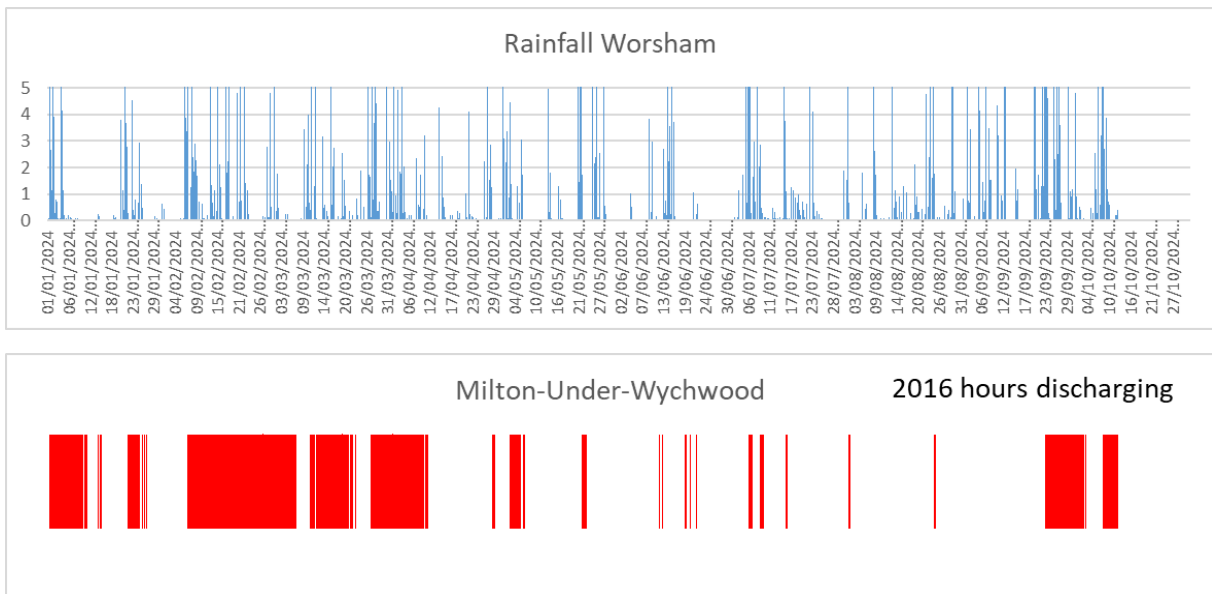
**Figure 8-2 Storm Overflow operation from January 2024 to October 2024.**

From Figures 9-1 and 9-2 it is obvious that this storm sewage overflow operates far more frequently than would be expected. The overflow operated for over 2,200 hours in 2023 and over 2,000 hours between January and October 2024. The MUW storm sewage overflow has the highest number of discharge hours in the Evenlode catchment. The Storm Overflow discharges untreated sewage far more frequently than could be explained by 'storm sewage effluent resulting from rainfall or snowmelt'.

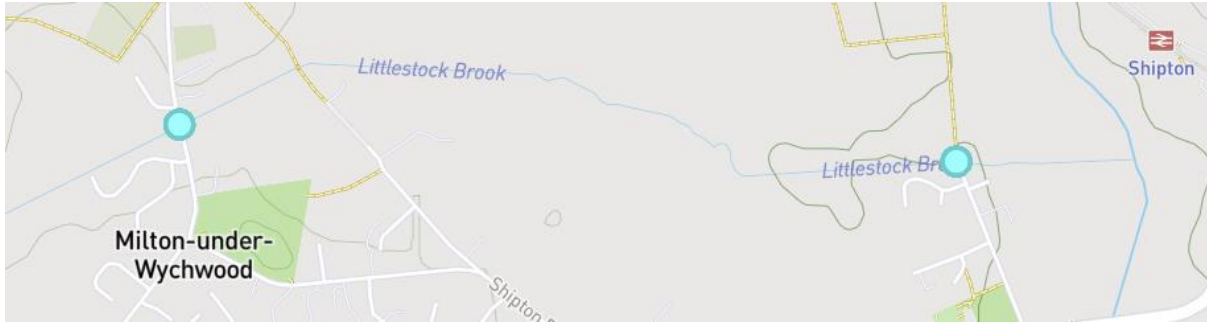
## Appendix 2 Citizen Scientist Riverfly data

<b>Species abundance (score) trends 2018 - 2023</b>						
<b>Upstream</b>	date	score	<b>Downstream</b>	date	score	
2017	03/10/2017	<b>3</b>	2017	02/10/2017	<b>1</b>	
				06/08/2017	<b>3</b>	
		<b>3</b>	divided by 1 = <b>3</b>		<b>4</b>	Divided by 2 = <b>2</b>
<b>Upstream</b>	date	score	<b>Downstream</b>	date	score	
2018	31/12/2018	<b>4</b>	2018	31/12/2018	<b>7</b>	
	31/10/2018	<b>4</b>		29/10/2018	<b>2</b>	
	17/08/2018	<b>5</b>		17/08/2018	<b>1</b>	
	30/06/2018	<b>6</b>		30/06/2018	<b>2</b>	
	29/04/2018	<b>7</b>		26/04/2018	<b>6</b>	
	02/02/2018	<b>8</b>		01/02/2018	<b>7</b>	
		<b>34</b>	divided by 6 = <b>5.66</b>		<b>25</b>	divided by 6 = <b>4.16</b>
<b>Upstream</b>	date	score	<b>Downstream</b>	date	score	
2019	30/12/2019	<b>5</b>	2019	30/12/2019	<b>5</b>	
	31/10/2019	<b>7</b>		31/10/2019	<b>5</b>	
	23/08/2019	<b>4</b>		23/08/2019	<b>5</b>	
	30/06/2019	<b>7</b>		30/06/2019	<b>5</b>	
	27/04/2019	<b>10</b>		26/04/2019	<b>5</b>

23/02/2019	<b>5</b>		23/02/2019	<b>3</b>	
		<b>38</b>	divided by 6 = <b>6.33</b>		<b>28</b>	divided by 6 = <b>4.66</b>
<b>Upstream</b>	date	score	<b>Downstream</b>	date	score	
2020	14/11/2020	<b>6</b>	2020	13/11/2020	<b>4</b>	
	01/09/2020	<b>5</b>		31/08/2020	<b>3</b>	
	25/06/2020	<b>5</b>		15/07/2020	<b>2</b>	
	30/04/2020	<b>6</b>		29/04/2020	<b>4</b>	
		<b>22</b>	divided by 4 = <b>5.5</b>		<b>13</b>	divided by 4 = <b>3.25</b>

Riverfly Sampling involves surveying the invertebrates that live in the watercourse. These are a useful indicator of river condition, as they live permanently in the river. They are a vital link in the aquatic food chain and are sensitive to changes in environmental conditions. They give an additional indication above spot chemical samples, as they experience all states of the river and any pollution events. The numbers of more sensitive species are quickly reduced if there is any pollution in the watercourse, but more resilient species will persist, providing an indicator of the long-term health of a river.
