ECP monthly water quality data report November 2024

Prepared by Laura Bannatyne and Rob Rustage

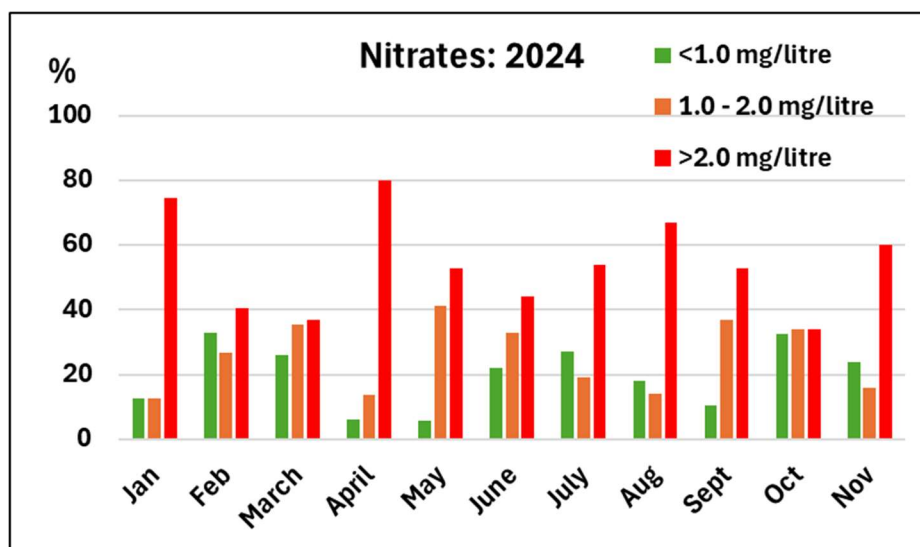
Figure 5: FWW nitrate concentrations January – November 2024

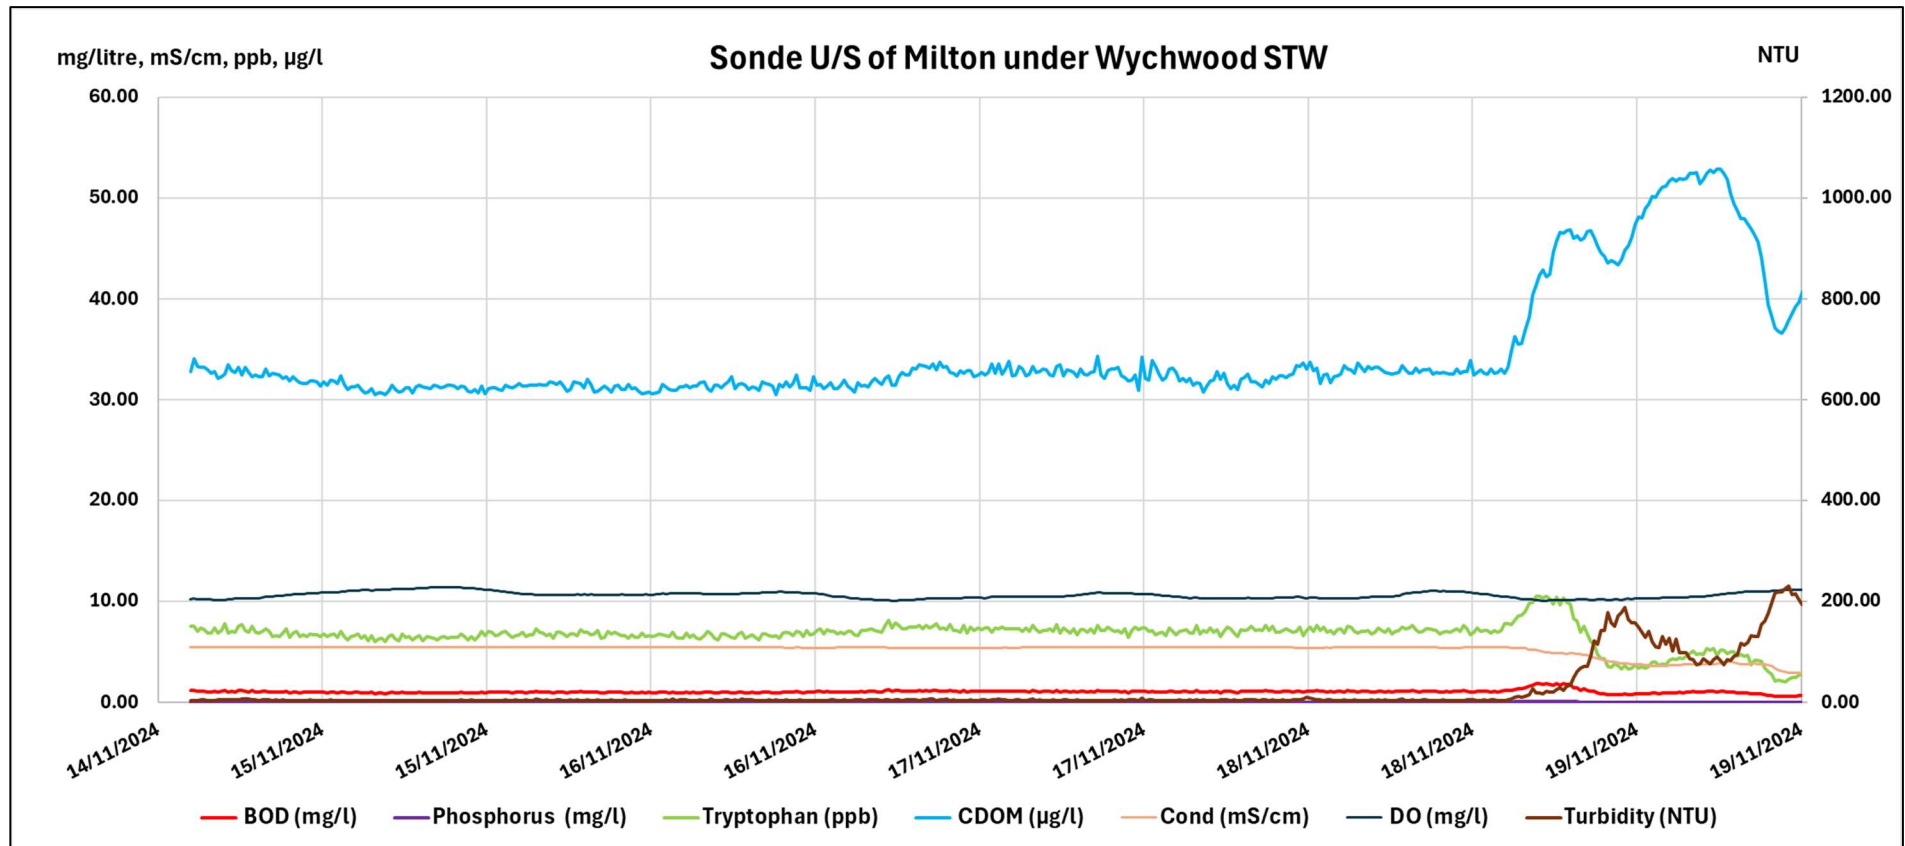
Figure 9: BOD, phosphorus, conductivity, DO, tryptophan, turbidity and CDOM for the Littlestock Brook at Heath Farm, upstream of Milton-under-Wychwood STW 14 - 19 November

BOD, CDOM, phosphorus, tryptophan, turbidity, conductivity and DO data from the sondes up- and downstream of the Milton under Wychwood STW are shown in **Figure 9** and **Figure 10** respectively. The axes values and line colours are the same for both graphs.

The rainfall that occurred on 19 November was reflected in the CDOM and tryptophan data both up- and downstream of the Milton-under-Wychwood STW, and particularly in the downstream turbidity data. CDOM, tryptophan, phosphorus, and turbidity were notably higher downstream of the STW, displaying the classic twice daily peaks due to domestic water usage. However, DO and conductivity remained steady throughout the period and at similar concentrations at both sites. Table 3 summarises the average values for sonde data 14 – 19 November up- and downstream of Milton-under-Wychwood STW.

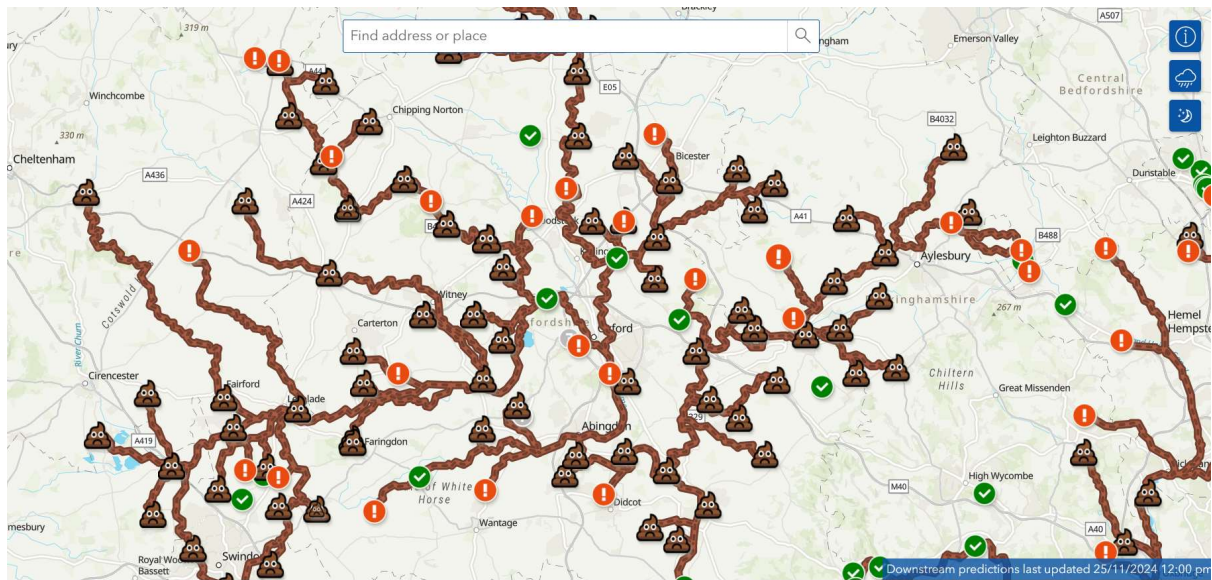
Storm overflows discharging on the 25th November.
